Experimental study of a delaminated sandwich composite subject to impact and/or compressive loading

**EXPERIMENTAL STUDY OF A DELAMINATED
SANDWICH COMPOSITE SUBJECT TO IMPACT
AND/OR COMPRESSIVE LOADING**

MASTER OF SCIENCE IN MECHANICAL ENGINEERING

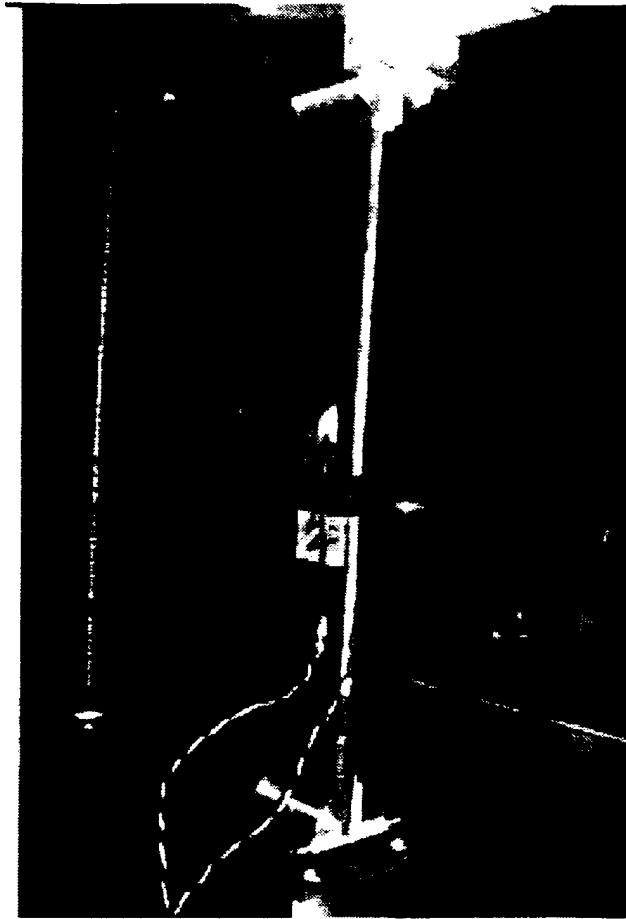
The test specimens were instrumented with 1.27 cm (0.5 in.) Measurements Group, Inc. CEA-13-250UN-350 precision strain gages mounted longitudinally and centered, one on each side. The gages had a gage factor of $2.12 \pm 5\%$. Gage outputs were connected to a Measurements Group SB-10 Switch and Balance Unit, and the strain readouts were provided by a Measurements Group P-3500 Strain Indicator. With the mounting fixtures installed on the compression test machine, the test specimen was fitted into the mounting fixtures and aligned with shims of various sizes. The center and axial deflections were measured with Sterrett dial indicators. Figure 2 illustrates the test specimen in the mounting fixtures for the typical, sans dial indicators, compression test setup.

Figure 2. Compression Test Setup

All compression tests were manually load controlled. The low speed loading was incrementally halted to allow recording of the strain, displacement and deflection. The specimens were loaded until ultimate failure occurred. The compression test data collected was imported into a Matlab computer routine to display the load-vs-strain results.

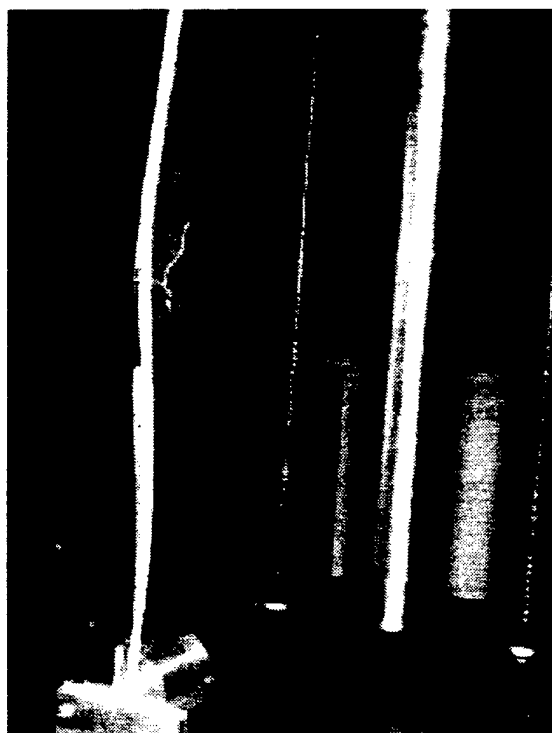
None of the samples failed in the first mode of buckling as expected of a normal, isotropic material. Upon loading, the test samples would generally bend in the half-sine shape as expected of an isotropic material such as steel or aluminum, but with continued loading the sample would change from the half-sine shape to an 'S' shape. Figure 8 reveals the typical 'S' shape of a sample at failure. The delaminated samples showed no preference in bending toward or away from the side with delamination.

Figure 8. Typical 'S' Shape in Compression Failure

The failure mode of all samples, delaminated and non-delaminated, was failure by core shear. The core shear of the delaminated samples always originated at the edge of the delamination. The core shear of the non-delaminated samples generally originated at the quarter-length point on the sample. Note the maximum force in compression with one half inch delamination was actually greater than the maximum force of the sample without delamination: 7.69 kN (1730 lb.) versus 6.41 kN (1440 lb.).
